**Geotechnical Investigation Report
Hugo Roundhouse Interior Renovation
Hugo, Lincoln County, Colorado
RockSol Project No. 813.01
April 26, 2024**

RockSol Project No. 813.01

April 26, 2024

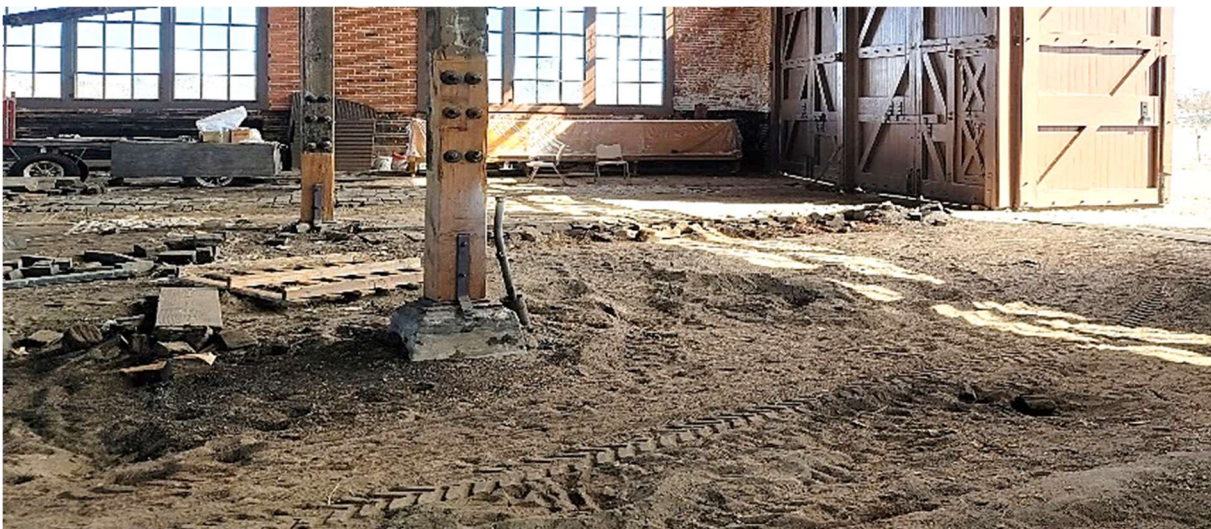
Surface materials encountered in our boreholes generally consisted of loose silty sand fill material with minor amounts of concrete, wood, ceramic, plastic, and glass debris. The debris is likely due to historic building usage and recent renovation work within the building. It appears that the interior was previously surfaced, at least partially, with wood block pavers. The silty sand fill material is likely a bedding material placed below the wood block pavers. All debris should be removed prior to construction of the proposed improvements. An example of debris on the ground surface is shown in Image 4.

Image 4: Hugo Roundhouse Surface Material Conditions

At a minimum, the ground surface underlying all floor slabs and structure foundations should be carefully prepared by removing all debris, scarification to a minimum depth of 6-inches, and recompact to the requirements for maximum dry density and moisture content listed in Table 10.1 of this report.

On-site excavated material may be used as backfill provided it does not contain unsuitable material or cobble particles larger than 3 inches. Unsuitable material includes, but is not limited to, concrete, wood, ceramic, plastic, and glass debris.

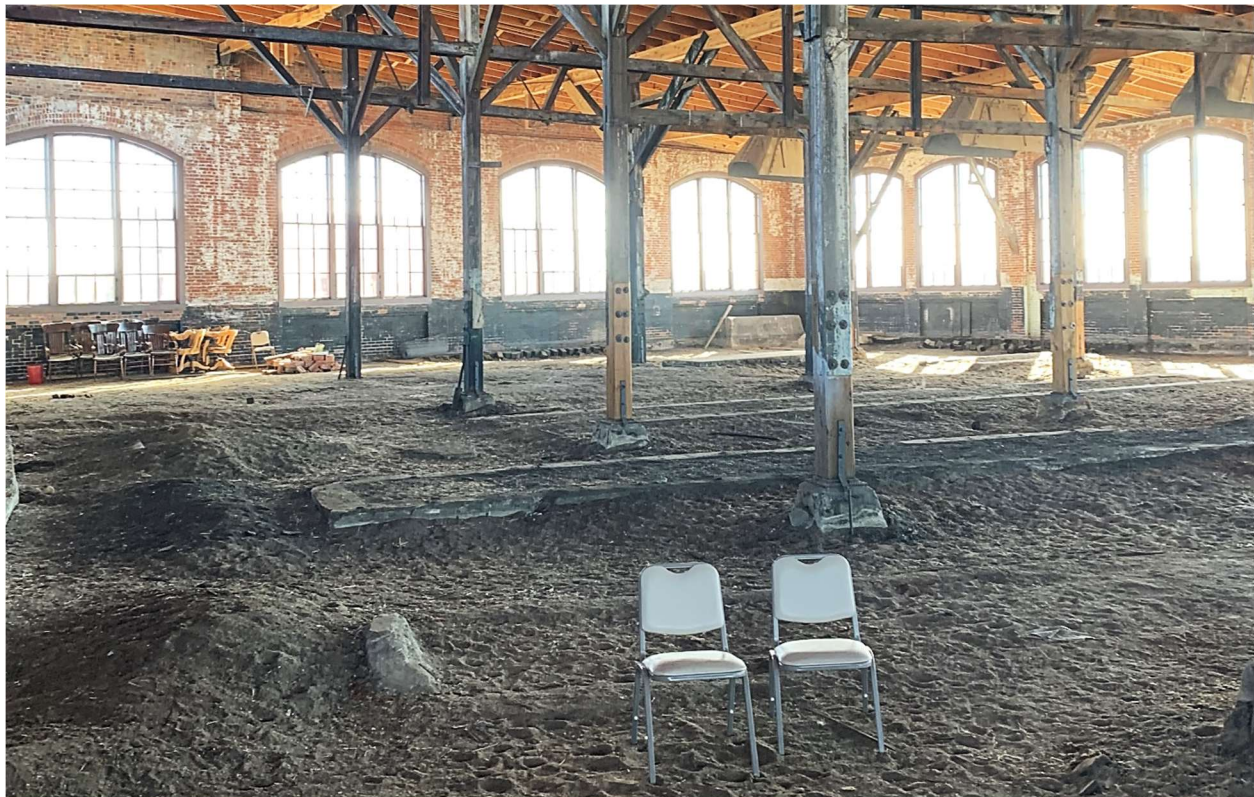
The existing engine service pits include concrete stem walls in varying conditions, see Image 5.

Image 5: Engine Service Pits – Upper Portion of the Concrete Stem Walls Visible

RockSol anticipates the existing concrete stem walls associated with the engine service pits will be removed or modified (cut) so they do not interfere with the concrete floor slab construction and future performance. RockSol recommends a minimum separation of at least 12-inches between the top of the stem walls and the bottom of the floor slab or foundation elements. See Section 10.0 for further discussion of the service pits.

RockSol understands that the stem walls may be removed either fully, or partially. At a minimum, RockSol recommends the upper 12-inches of soil within the service pits be excavated and stockpiled for re-use. The bottom of the excavation shall be moisture conditioned and compacted

to the requirements in Table 10.1. The removed soil may be replaced in lifts of 8-inches, or less, and moisture conditioned and compacted per Table 10.1.

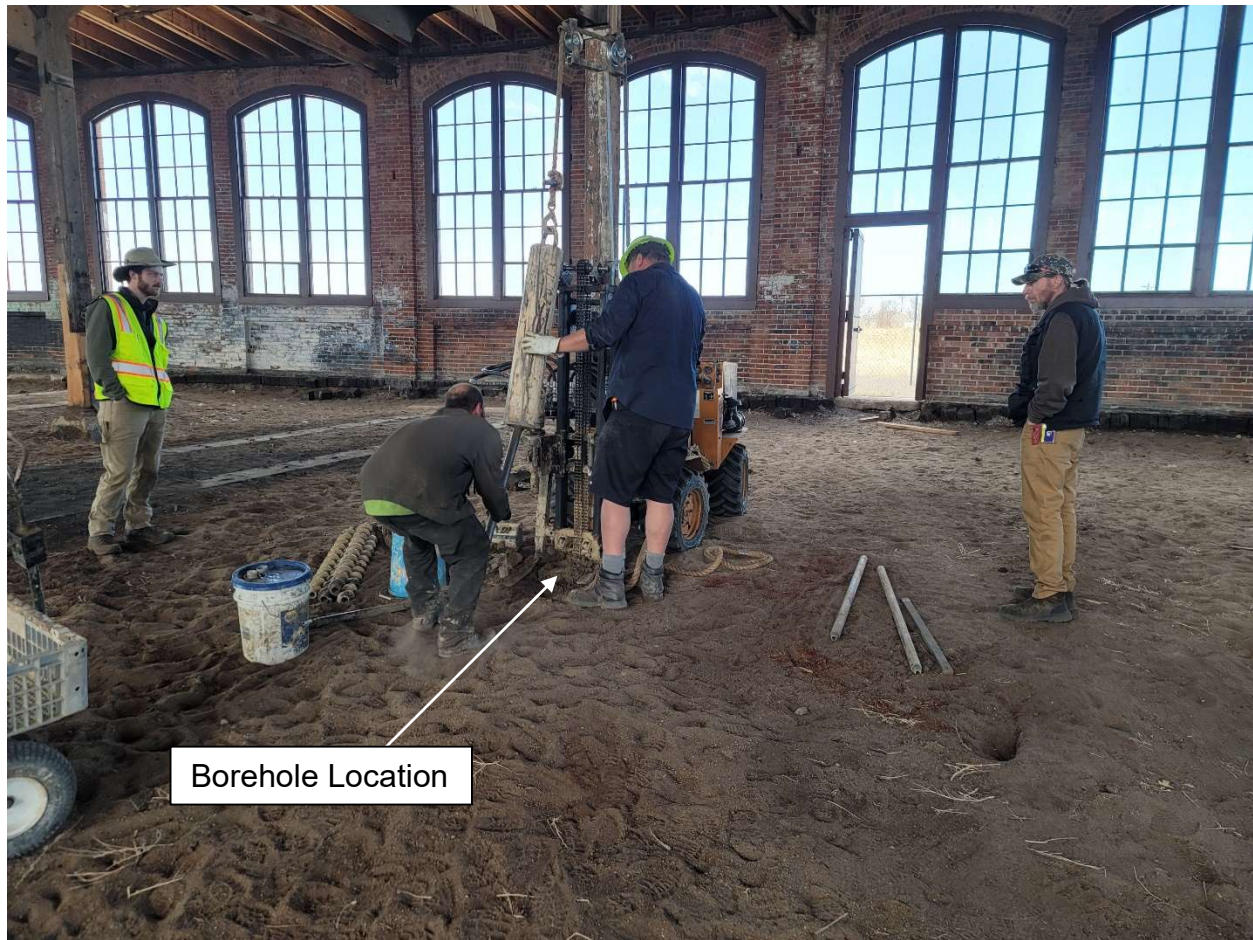
Borehole Location – B-1

Photograph Taken Looking West

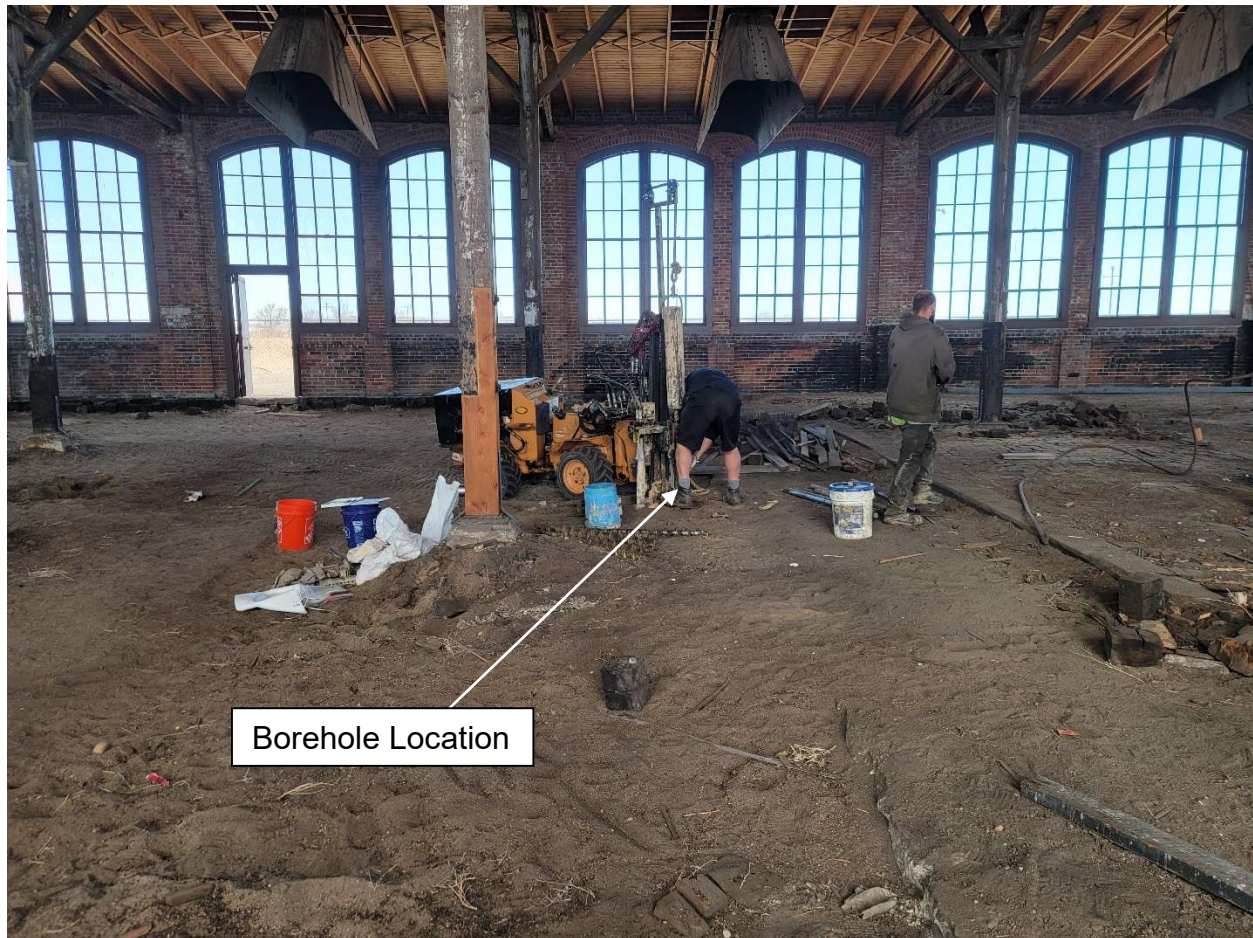
Borehole Location – B-2

Photograph Taken Looking West
